**OLD ST HELEN'S CHURCH,  
ORE, EAST SUSSEX**

**AN ARCHAEOLOGICAL  
INTERPRETATIVE SURVEY  
OF**

**Commissioned by  
SUSSEX HERITAGE TRUST**

**PROJECT REF. 5436**

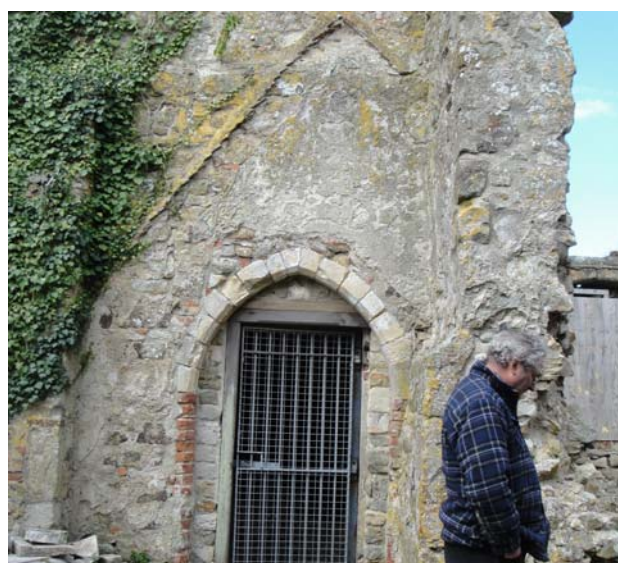
*South wall of tower showing doorway (A2) and  
roof scar of porch (A5).*

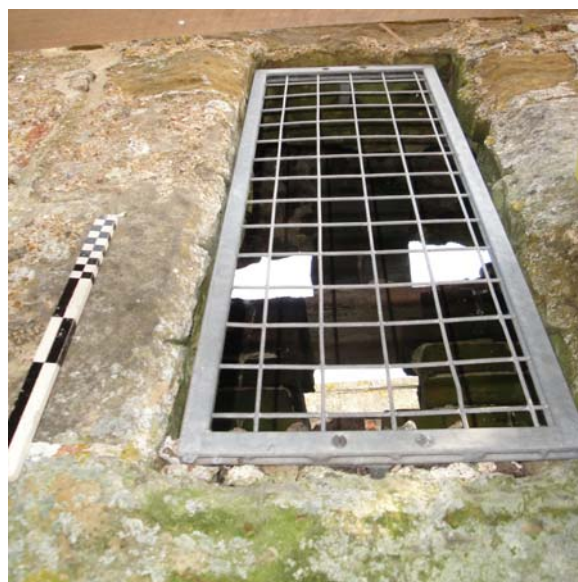
*Window (A13).*

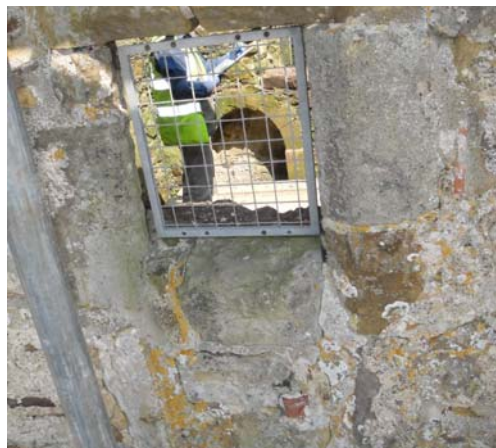
*Exterior of window (B8).*

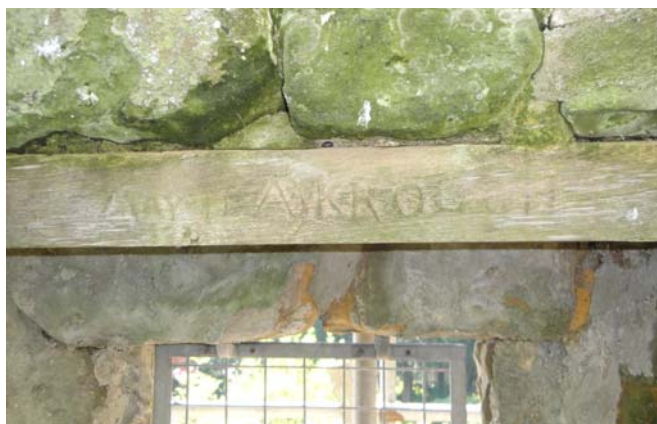
*Timber lintel at head of window (B8).*

Internally, the splayed jambs of the opening survive in good condition and incorporate neatly-dressed sandstone quoins. The rear arch has gone, though sufficient survives at the spring points to indicate it was a segmental arch formed of roughly-shaped rubble blocks. A timber (with inscription) has been inserted to help support the wall above the opening. There is a steeply-sloping cill, added (to replace an almost flat cill) when the lower part of the external surround was blocked.

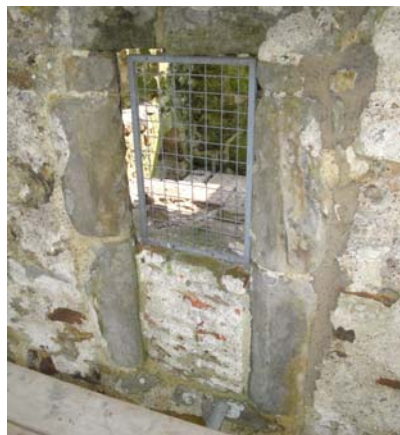
*Window (C5).*

Internally the opening has splayed jambs supporting a rough, undressed segmental rear-arch. Both internal jambs are damaged immediately above the brick blocking where a deep socket has been cut out of them, but they are intact above and below that level. Internal width of the opening = 1.30 metres; height of the jambs' quoins measured from rubble cill to the spring point of the rear arch = 1.26 metres.

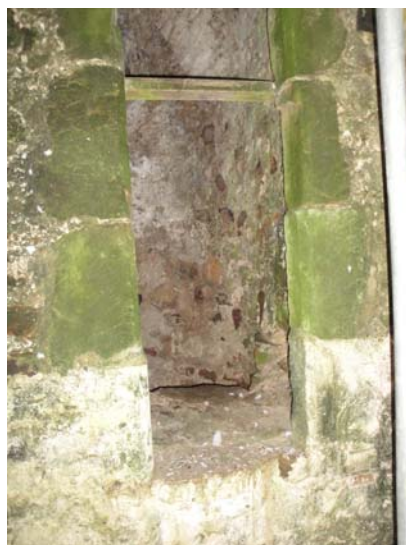
*Base of doorway (C13) showing where the cill has been lower by the depth of one block.*

Depth of jamb measured from the inner face of the tower to the door rebate = 160mm. Within both jambs the lowest stone (360mm in height) is formed from a different stone and is of a different date — in fact, they are not shown in the 1992 stone-by-stone drawings and seem to have been inserted during 1990s repairs to replace a rough area of stonework at the base of the opening. Significantly, the top step and landing of the spiral step have been chopped down indicating that at some date the opening has been heightened by deliberately lowering its base. Internally the rear part of the doorway is 650mm wide.

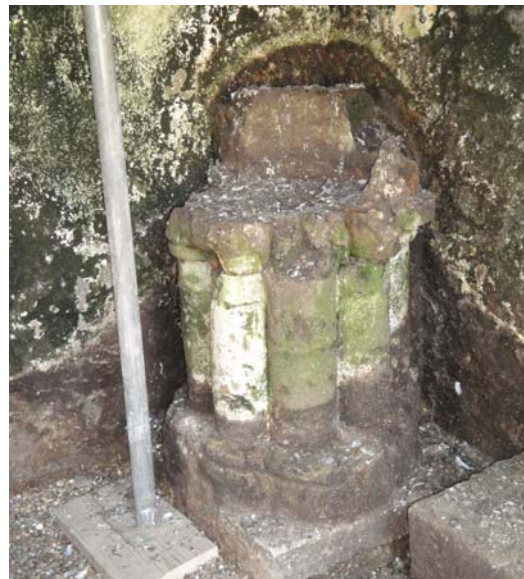
*Remains of font (C19).*

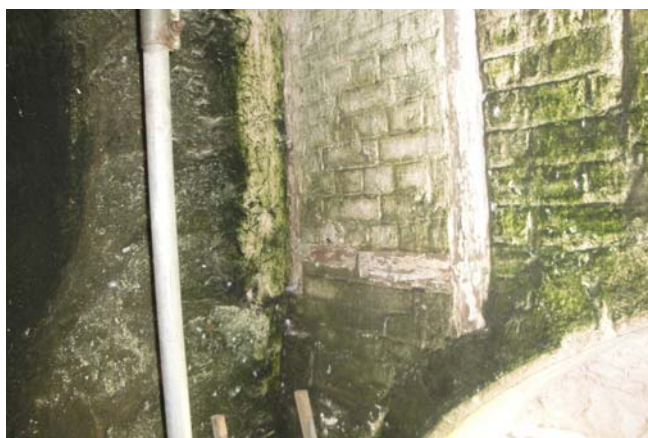
*Blocked doorway (D7) leading to former gallery.*

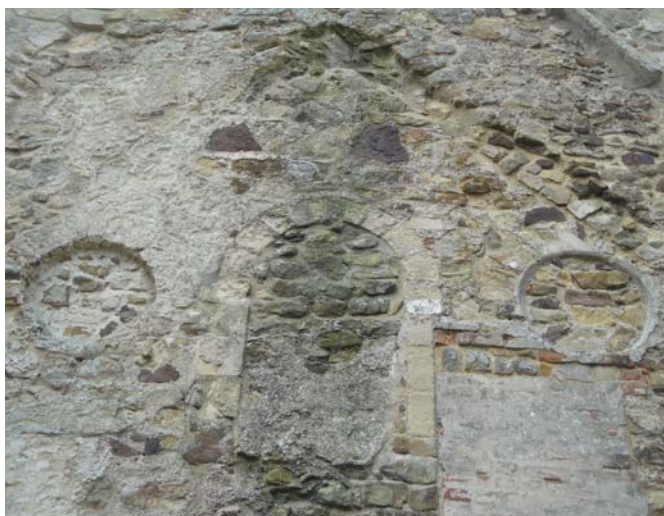
*Window (D10) in the centre with circular window (D12) on left and circular window (D13) on right. Roof scar (D14/D15) is visible above the windows.*

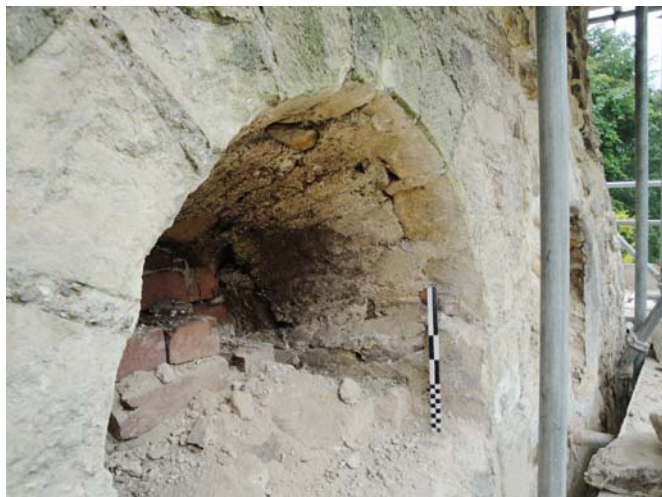
*Window (D10). East face after removal of 19th-century blocking to the upper part. Note the rough nature of the rendered to the splayed part of the head and the fact that the render spalls over the dressed Caen stone.*

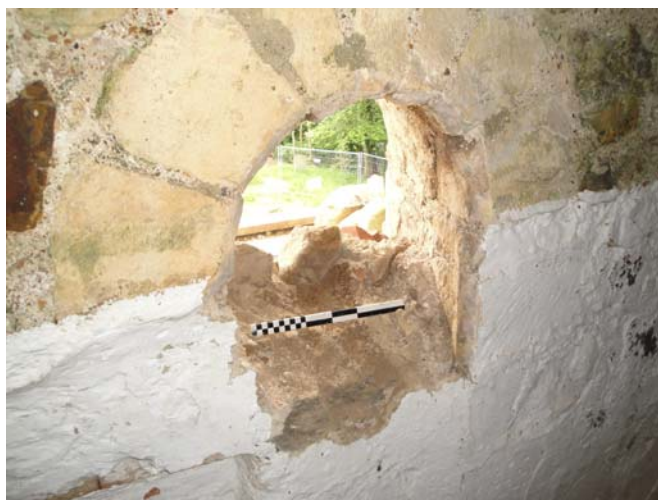
*Window (D10). West face after removal of 19th-century blocking to the upper part.*

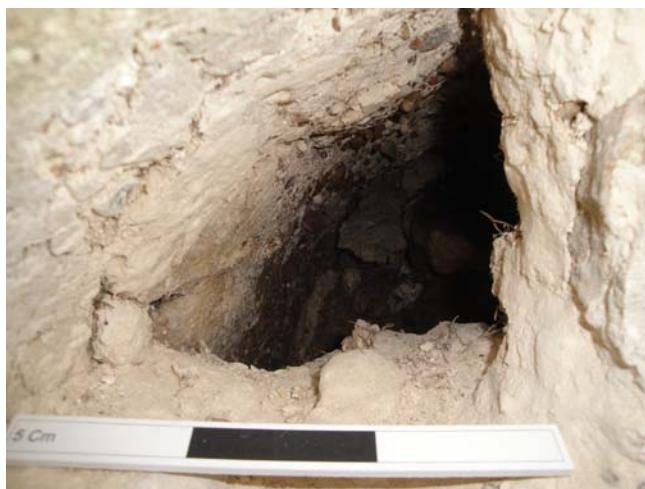
*Circular window (D12) showing shuttering marks on interior of window head after temporary removal of a blocking stone.*

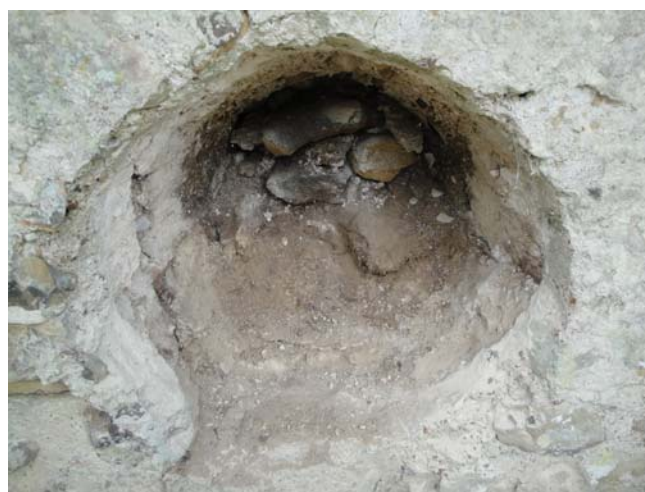
*Circular window (D12) viewed following removal of the eastern skin of blocking on 1/8/2012.*

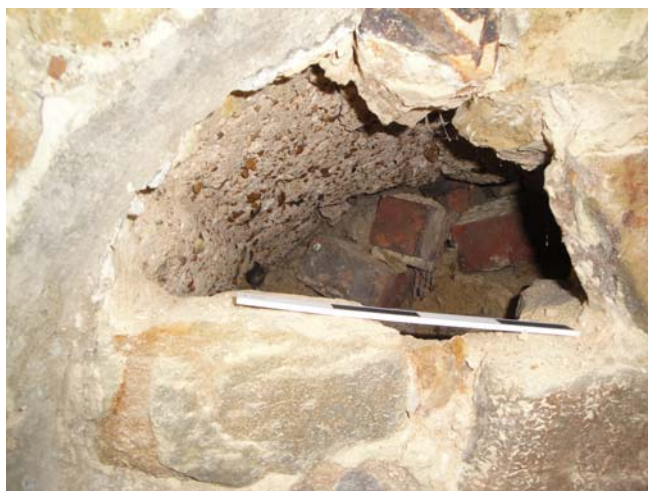
*Circular window (D13) showing shuttering marks on interior of window head after temporary removal of a blocking stone.*

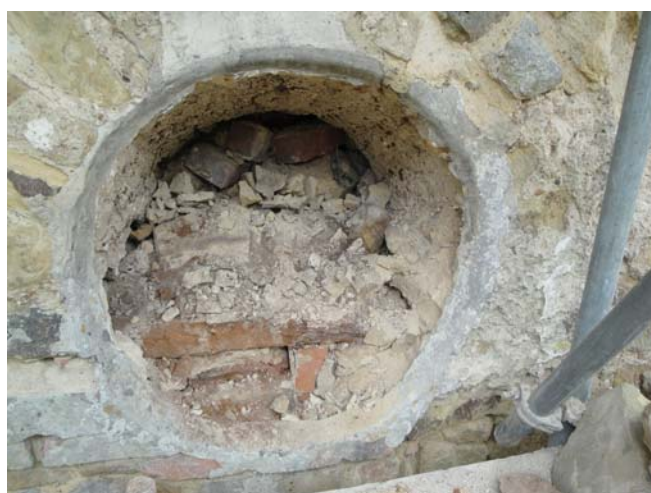
*Circular window (D13) following removal of external blocking, 1/8/2012. Note the high-level timber lintel over blocked doorway D7/D11 and the way the face of the lintel is set back and the brickwork over the doorway's low-level lintel (not visible in photo) is roughly curved in order to maintain the window's outline as an antiquarian feature within the face of the wall.*

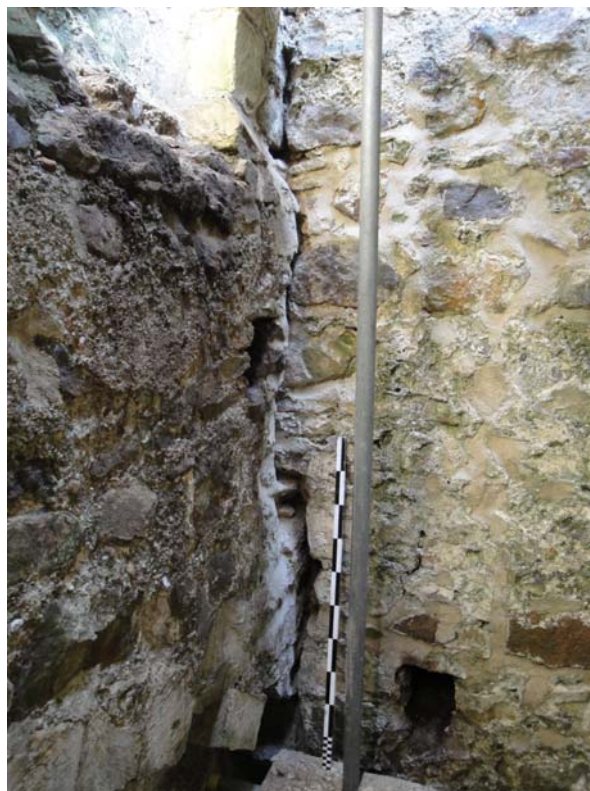
*Block-bonded straight joint D43 rising from arch D25 to chamfered offset at cill level of openings D18 and D19.*

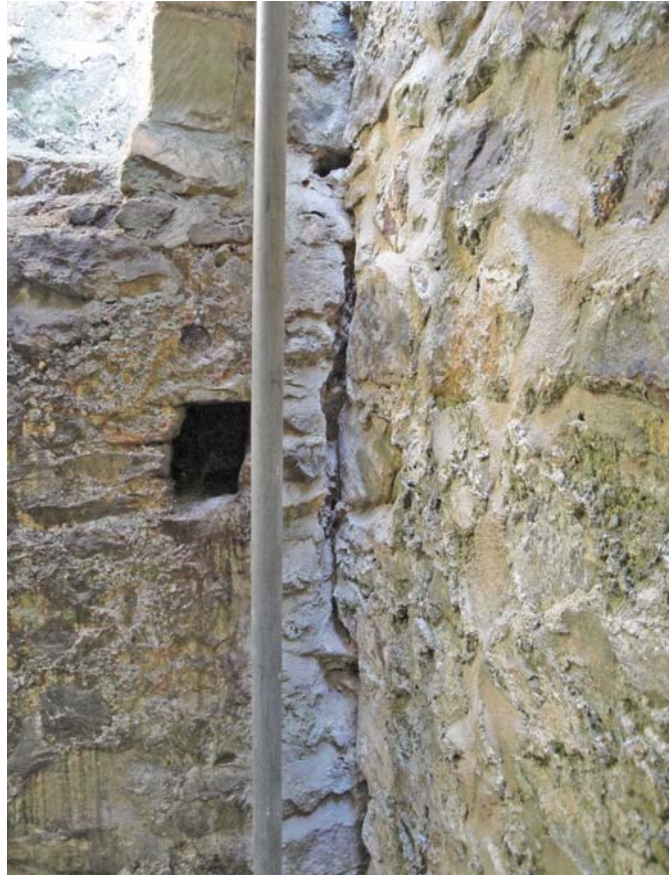
*Detail of block-bonded straight joint D43 rising from arch D25 to chamfered offset at cill level of openings D18 and D19, viewed from west. In the centre of the picture, note the shallow depth of the pocket cut into the old west face of the phase-2 bell turret forming a nominal joint between the two walls.*

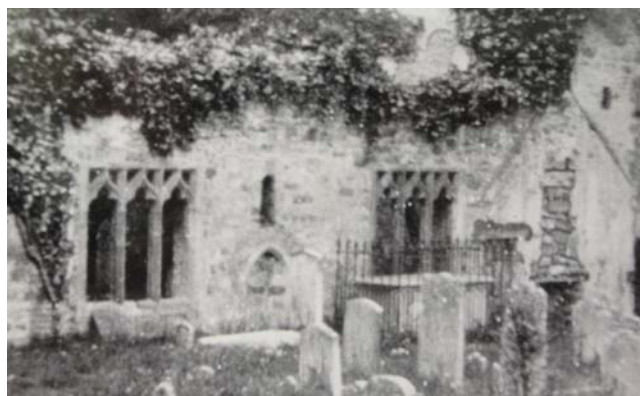
*Photograph showing the north wall of the nave before  
windows F4 and F8 had fallen. [Photo from HAARG archive].*

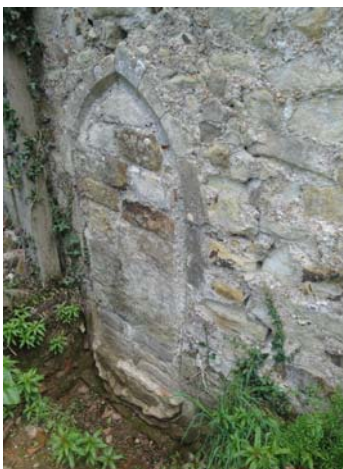
*Blocked doorway (F7).*

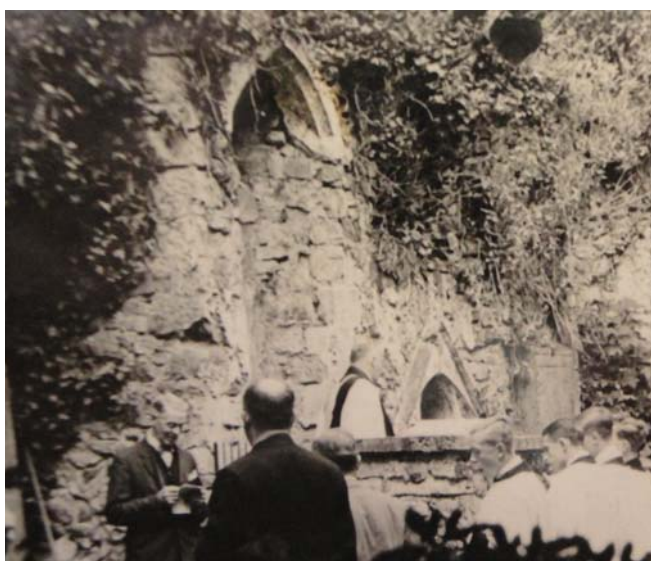
*Window G2 shown prior to it having fallen.  
 [Photograph from HAARG archives].*

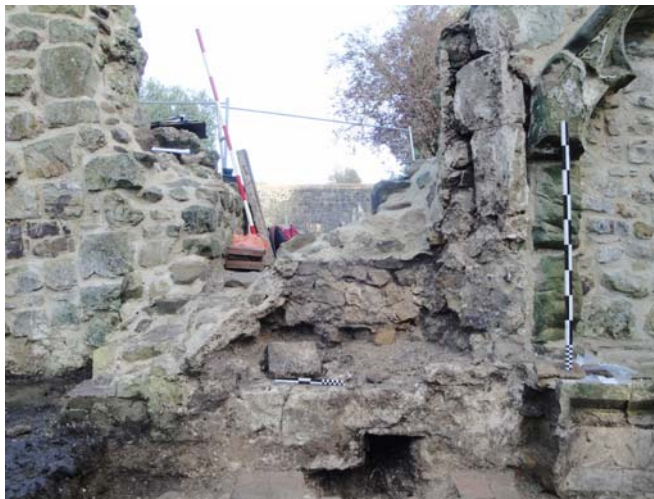
*Window G2. Internal face after removal of pulpit showing dressed splayed quoins, cut-off phase-4 cill and phase-5 downward extension.*

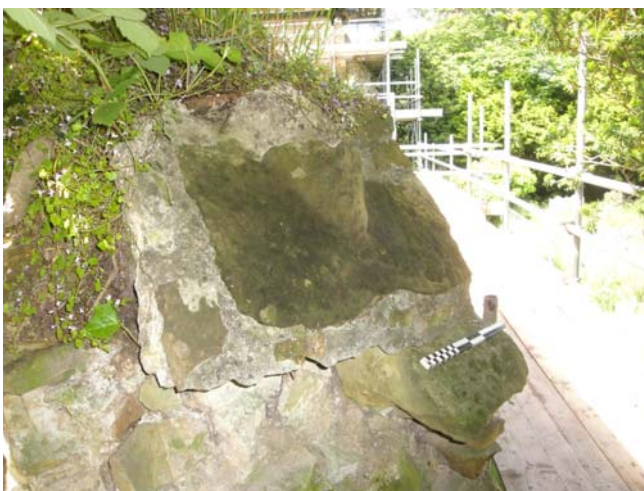
*Remains of finial on offset of Buttress (G6).*
