**OLD ST HELEN'S CHURCH,  
ORE, EAST SUSSEX**

**AN ARCHAEOLOGICAL  
INTERPRETATIVE SURVEY  
OF**

**Commissioned by  
SUSSEX HERITAGE TRUST**

**PROJECT REF. 5436**

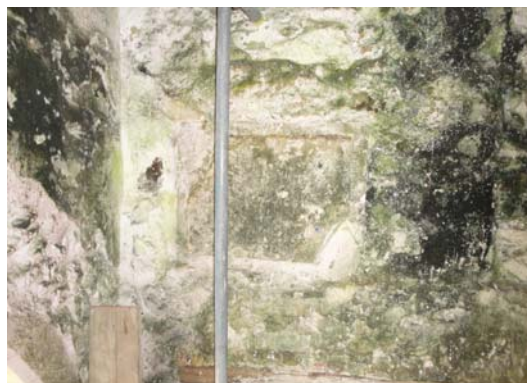
A17-A20 Monument scars ? ?

Scars in wall face indicating where wall plaques have been removed.

*Monument scar (A17).*

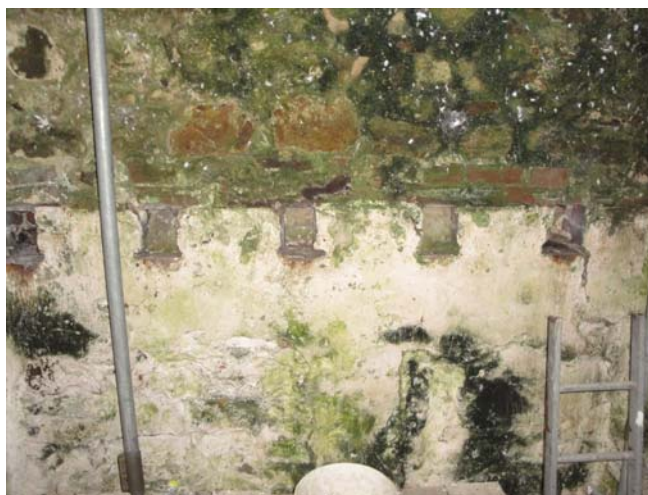
A21 Floor Level 3/8 L12C/19C

Floor level indicated by top face of wall plaster and joist sockets, 130mm wide x 170mm high, extending on average 160mm into the wall and now formed using 19th-century brick. Although all present evidence is 19th century, the cill of doorway C13 in the opposite (north) wall indicates that there was a floor at this level from the outset.

*Joist sockets (A21).*

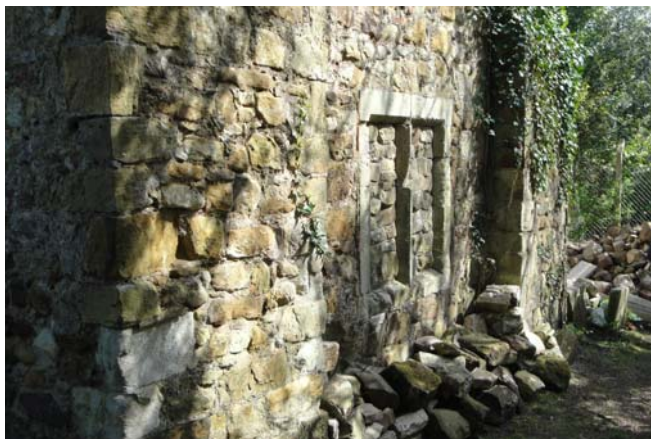
*Window (B2).*

B3	Repair	8	19C	Internally the opening has square-set jambs and a flat cill, all constructional details of which are masked by plaster. Above is a shallow segmental rear arch constructed of bricks laid on edge, now lime-washed.  Area of repair beneath the window cill of B2, with what looks like a straight joint at the northern edge, under the northern light. The area is far too narrow to represent a blocked doorway. There is also a rough area of repair over the opening, where needles have been put through the wall to hold it up when the opening was cut. There are no obvious signs of a removed earlier arch, which tends to confirm the early illustrations which,
----	--------	---	-----	---

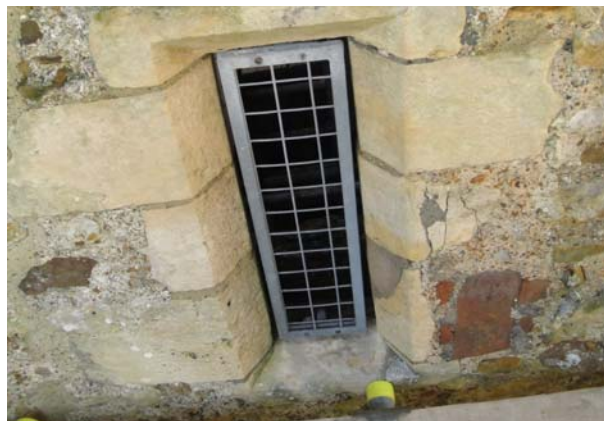
*Window (C3).*

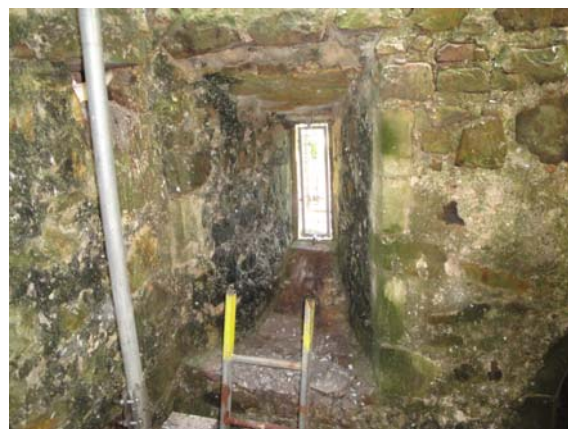
Internally the opening has splayed jambs with the jamb of its western reveal positioned 65mm off the internal face of the tower's western wall. Internal width of the opening, measured between the jambs, is 860mm. The western jamb is now fragmentary, but the eastern jamb has good Caen stone dressings rising 1.19 metres above the cill. At this point the Caen stone terminates, but the jamb extends up a further 300mm, but much more roughly finished and using sandstone rather than Caen. There was probably originally a rear arch in this location, behind which are two massive flat slabs which

*Interior of window (C3).*

form the majority of the opening's head. The two slabs slope downwards from south to north. The southern edge of the slabs, at a point 170mm in from the internal face of the tower, the soffit of the slab is at 1.33 metres above cill. At the base of the opening, the inner 500mm of the cill is virtually level, beyond which it rises steeply to the external cill. At this point the wall thickness is 900mm.

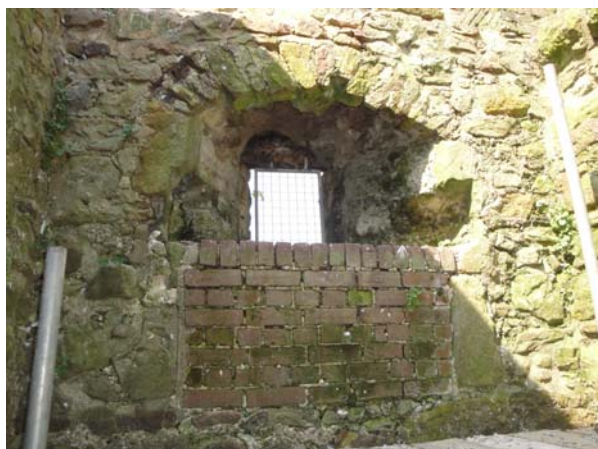
*Interior of window (C5).*

measured across the face = 90mm. As with opening B8 in the west wall, the jambs have a 30mm groove and also show angled cuts for an added slanting louvre. The groove continues the full depth of the opening, but the cuts for louvre terminate at the ?19C brick blocking, which extends through to the internal face of the wall. The external face of the brick blocking has at some time had white render applied to its external face. The head of the opening has two sockets for former bars. All the way around the opening the joint between the surround and wall has been made good and the face of the surround has been covered in external render, parts of which still remain.

Internally the opening has splayed jambs supporting a rough, undressed segmental rear-arch. Both internal jambs are damaged immediately above the brick blocking where a deep socket has been cut out of them, but they are intact above and below that level. Internal width of the opening = 1.30 metres; height of the jambs' quoins measured from rubble cill to the spring point of the rear arch = 1.26 metres.

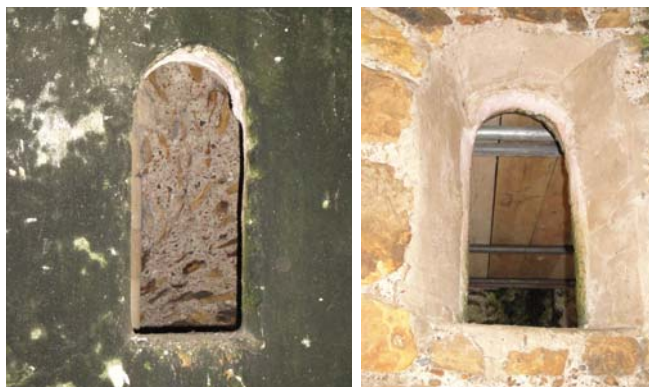
*Opening (C15).*

entirely rendered. The south face of the opening is 240mm wide with jambs 480mm high from cill to the spring-line of the arch. In plan, the southern 120mm of the jambs are set square and are un-chamfered, beyond which the internal jambs are splayed to give the opening an internal width (at the spiral staircase) of 410mm. Thickness of the wall between the interior of the tower and the spiral staircase, at its thinnest point is 270mm. It should be stressed that there is no visible details to prove that this is an old opening.

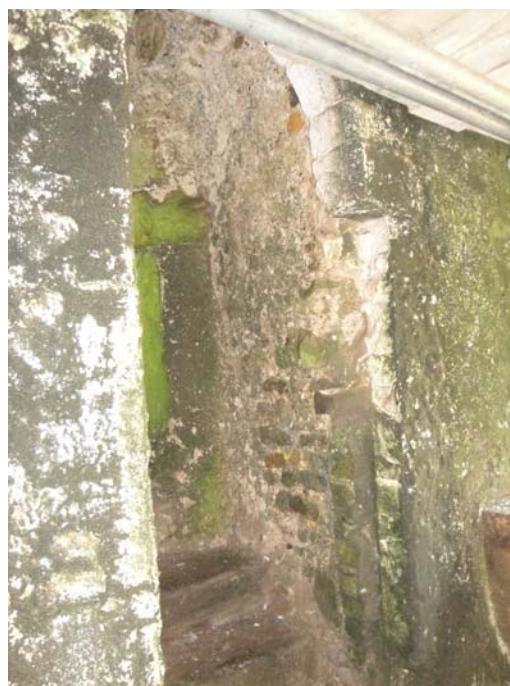
Ground-floor doorway leading to spiral staircase with modern step at base. The doorway has been heightened by lowering the cill (marked by an absence of dressed stone at the base of the west jamb) and at the same time the bottom steps of the staircase were adjusted (central newel does not extend down to the base and the base of the walls adjacent to the steps have been hacked). Originally there must have been a flight of steps within the tower leading up to the doorway. In the doorway's present cill is formed a recess for a timber cill to the opening. The majority of the east jamb has been cut back to take a former timber door frame inserted at the same times as stair C16, but otherwise the jambs and head of the opening are intact. Incorporated into the south face is a neatly dressed narrow continuous chamfer which measures 40mm across its face. Any stops which may have existed at the base of the chamfer have been destroyed. In plan, the thickness of the opening measured from the internal face of the tower to the recess for the door = 160mm. Within the spiral staircase, the

*Doorway (C17).*

eastern internal jamb of the opening is set square as if to take a door leaf when open, and a locking point visible in the west jamb seems to confirm that the opening was originally fitted with a door. However, any such door could not have been of full height as the steps leading through the thickness of the wall to the base of the spiral staircase would have got in the way. It is therefore assumed that the door did not extend down to the base of the opening.

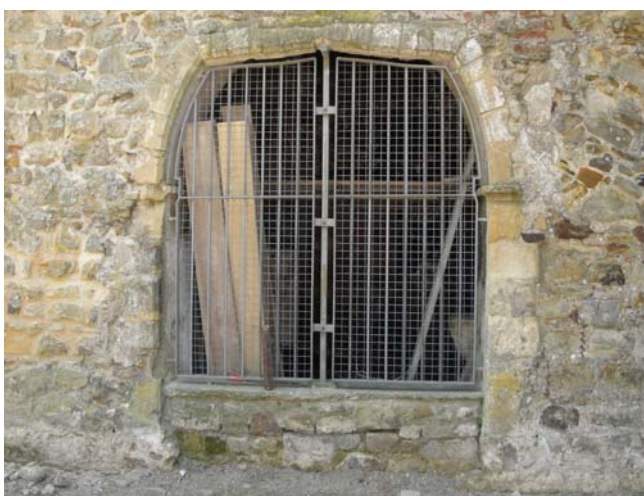
*Tower arch (D5).*

unknown, but contemporary with the original arch).
D6	Wall	8a	1816	Rebuilt area of east face to wall D1, above the tower arch (D5). The area of reconstruction is the same date as the re-fixed top to the tower arch and doorway D7 cut through in 1816 between the new gallery in the nave and the tower.
D7	Doorway	8a	1816	Doorway cut through between tower and western gallery. Now blocked using 19th century brick, rendered over. On its internal (west) face the opening retains a timber door frame, the top face of the cill of which is located 30mm above the apex of the tower arch (D5). On this face the area to the south of the southern jamb is constructed in brick, which does not look overly different to the phase 9 brick blocking the opening itself. Internal height of doorway from top of cill to frame = 1.25 metres, then there are two courses of brick resting on top of the doorway's timber head and then a course of bricks laid on edge with a further timber lintel above that with some partially rendered making good above. The high-level timber intrudes into the lower part of the splayed jamb of window D13 (which see).

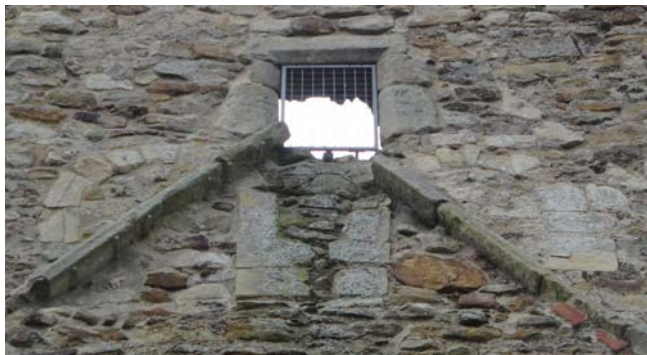
D18	Window	2	L12C	Blocked belfry opening, probably initially intended as an opening to accommodate a bell. In the east face it has an un-chamfered semi-circular head, neatly dressed in Caen stone. The south jamb has been partly destroyed at the base by the intrusion of roof weathering D17, but the remains of a projecting, chamfered, Caen stone wall-offset at the base of the jamb

*Roof weathering (D17) and blocked 'window' openings (D18 and D19).*

D19	Window	2	L12C	Blocked belfry opening, probably initially intended as an opening to accommodate a bell. The details generally are all as for D18, complete with projecting Caen stone chamfered offset/cill to both jambs, but on the east face that to the north jamb has been entirely destroyed by the insertion of roof weathering D17, as too has the lower stone of this jamb. The blocking contains good remains of external render on the east face, above D17.
D20	Wall offset	2	L12C	Wall offset, approximately 100mm wide, now much damaged but originally with chamfered top face (as evidenced by the cills of D18 and D19). It should be noted that this offset is located about 230mm lower than that in the north, west and south walls of the tower.
D21	Chamfered Offset	2	L12C	Chamfered Caen stone offset at east end of the tower's north wall.
D22	Window	5	L14C-E16C	Square-headed window intruded immediately above the nave's higher roof line (D17) which seems to stop square at its apex in order to avoid the cill of the window. On the east (external) face the opening has a weathered and dressed chamfered sandstone surround with a 30mm groove for former grill(?) The lintel is pinned using a plain tile. Two bar sockets in the head are now reused by a modern grill. The junction between roof weathering D17 and the window surround shows that the

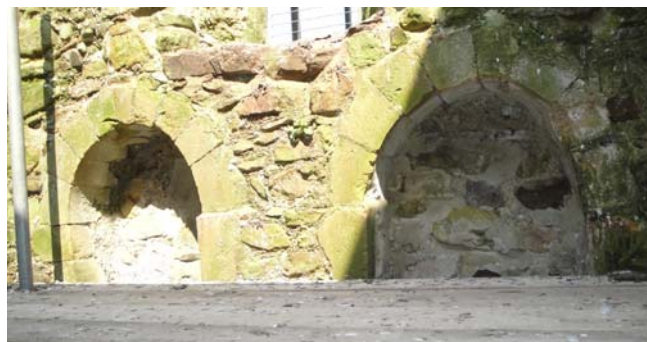
*'Window' openings (D18 and D19) from interior of tower.*

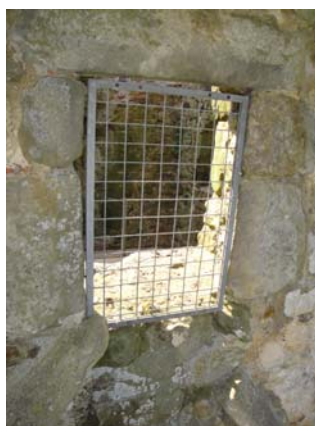
Window (D22).

window is either earlier or contemporary with roof-line D17, but if earlier why is its cill set so much higher than those of the windows in the tower's south, west and north walls? In all likelihood, therefore, the two are contemporary with one another. Splayed jambs and flat cill. The thickness of the wall at this point is 600mm.

The internal width of the opening = 920mm; height from cill to spring point of segmental rear arch = 680mm. The splayed internal jambs survive tolerably, well but the internal face of the rear arch has been entirely lost.

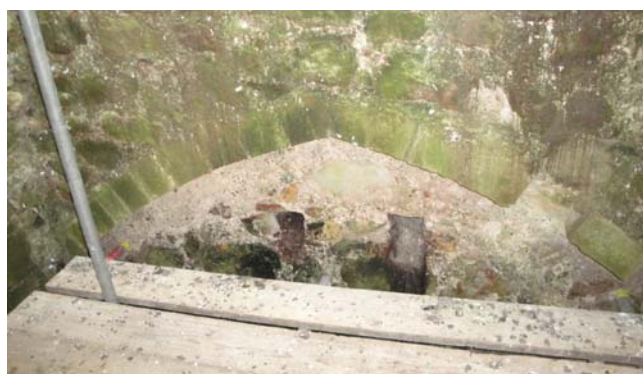
D23	Tile pinning	8c	1817x1828	Single course of plain tile as levelling to old wall. It may be the same date as the parapet (D24), but could represent levelling under the wallplate of the tower's earlier 'Sussex cap' roof.
D24	Parapet wall	8c	1817x1828	All as A16.
D25	Supporting Arch	2	L12C	Arch with a 140mm projection projecting from the west face of the nave's west wall (internal face of tower's east wall) supporting the bell parapet/east wall of the tower above the original thinner west wall of the nave. As with window D10 and openings D18 and D19, the arch is un-chamfered and has neatly dressed Caen stone voussoirs. The lowest visible voussoirs, at the point where they abut the tower's north and south walls, are bedded into the wall and continue into the walls, but for how far is unclear. Immediately beneath the arch both the north and south wall are straight jointed to the earlier nave wall (D1) but in each case the joint detail above the level of the voussoirs is hidden by modern re-pointing.

*Support arch (D25) to former bell turret.*

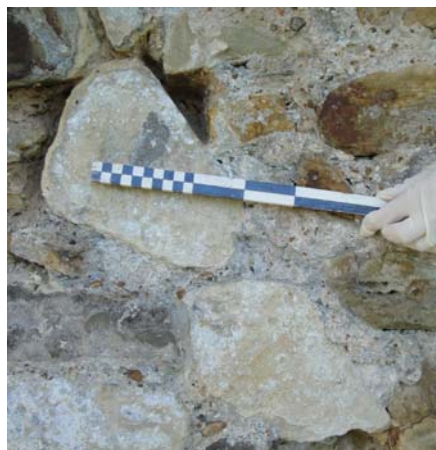
D40	Dressed wall top	2	L12C	Neatly-dressed Caen stone blocks with upper face neatly cut to form the verge of a gable. There are four dressed blocks of Caen stone visible in the east face (upper stone badly discoloured on the face) and one in the west face. If the alignment is projected downwards, the verge coincides with chamfered offset D21 in the tower's north-eastern quoin.

*Two dressed Caen stone blocks indicating top of turret (D40).*

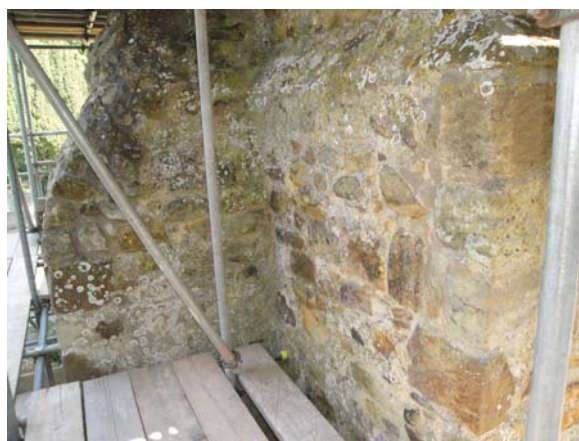
*Roof of stair turret (E3).*

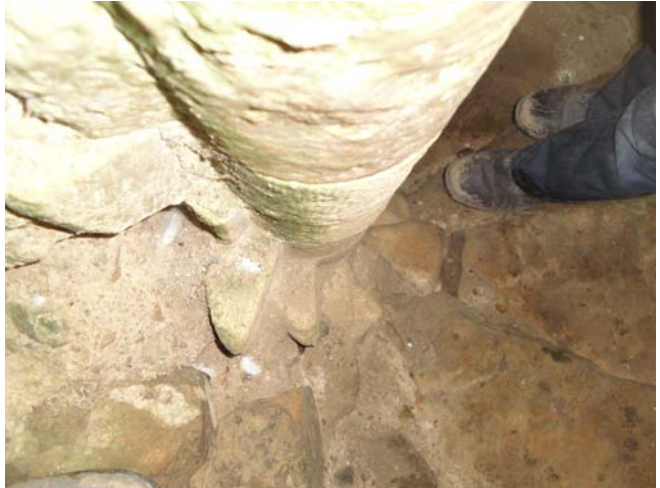
E4	Spiral staircase	3	L12C	Spiral staircase rising from ground-floor doorway C17 within the tower to doorway C13 at former belfry level within the tower. The steps within the lower part of the flight, from doorway C17 to the lowest course of the central newel, has been reformed at a lowered level, and similar has occurred at the head of the flight, adjacent to doorway C13. Generally the spiral stair passage measures about 660mm wide and on average 1.95 metres to the spring-line of the spiralling stone barrel-vaulted ceiling. The soffit of the barrel vault is roughly formed and
----	------------------	---	------	--

*Looking down the spiral staircase (E4).*

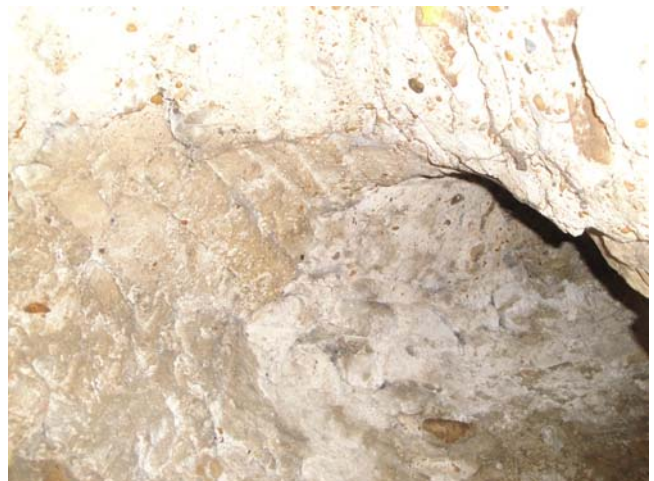
shows copious amounts of mortar showing the very clear impressions of the lath-like timber shuttering. There average rise on the steps in 175mm.

*Marks of the shuttering used in the construction of the roof of the spiral staircase (E4).*

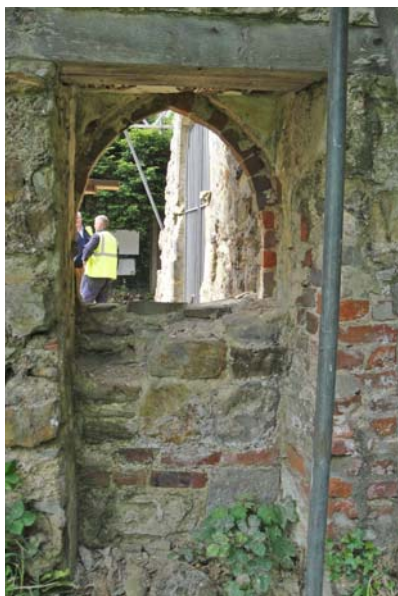
No	FEATURE	PHASE	APPROX DATE	NOTES
F1	Wall	1	L11/E12C	North wall of nave, on average 650 mm thick. Faced in rubble sandstone, many of the blocks very roughly squared and roughly coursed. All laid in a gritty lime mortar. Some lift lines are visible. The wall was later raised (see F15) the junction between the two being particularly noticeable on the interior where the top part of wall F1 is battered whereas the raising has a vertical face. Externally traces of a gritty lime render is still discernible in a number of places and, significantly, this continues behind the junction of added buttress F13, indicating that the wall was rendered externally prior to the buttress being added.
F2	Doorway	8c	1816x1832	Doorway cut through from the nave to the former vestry, which was added between 1816 and 1832. Its two-centred arch and east jamb are formed from brick, roughly cut to form a chamfer and the brickwork then hidden by neat rendering (now fallen in many places). The main arch of the doorway faces into the nave, with the rear face towards the north, visible in the vestry. On this northern side the jambs are bridged by a timber lintel. On its southern face the doorway is 1.90 metres high and 0.80 metres wide.

*Rear arch of  
intruded  
doorway (F2)  
leading from nave  
into the 19th century  
vestry.*

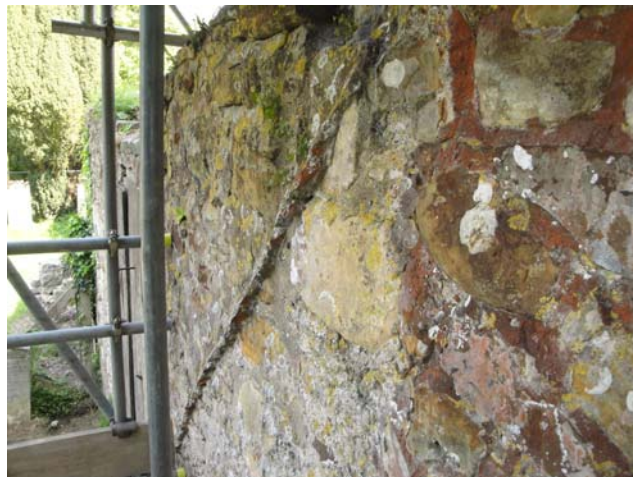
F3	Listing	8c	1816x1832	Mortar listing applied against the northern face of the wall indicate the roof-line of the demolished nineteenth century vestry. The vestry is not shown in F. W. L. Stockdale's illustration of the church from the north-west made in 1816, but is shown in George Rowe's illustration from the north-east made
----	---------	----	-----------	---

in about 1830, and in a dated sketch of 1832.

*Mortar listing (F3) showing  
the line of the vestry roof.*

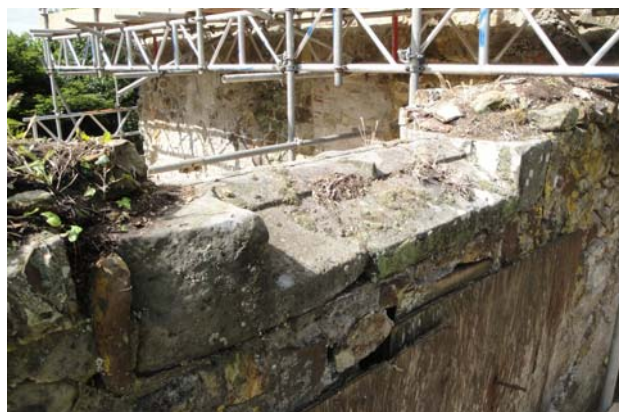
F5	Window	8e	1832x1859	<p>The surviving stone cill of a two-light dormer window inserted to light the western gallery. The window did not exist in c.1830 when George Rowe drew the church from the north-east, nor is it shown in a dated sketch of 1832 (HMAG TP 1584), but did exist by 1859 when W. F. Saunders made a similar illustration. The chamfered main frame of the dormer was set on the centre line of the wall with deeply chamfered internal and external surrounds. The remains of the internal splayed jambs survive and are of brick, rendered over, and on this side there is a flat cill cut into the top face of the voussoir to the relieving arch of window F10. Curiously, the groove for the glazing extends across the seating for the central mullion and beyond the seating for the side jambs. The stone is a gritty sandstone and appears not to be local.</p>
----	--------	----	-----------	---

*Cill of added dormer window (F5).*

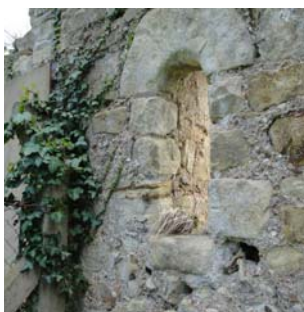
F6	Window	1	L11/E12C	<p>Small round-headed window splayed internally to an opening 550 mm wide and 900 mm high. On the outside its head is formed by a single stone lintel, which is supported by jambs each constructed using three stones, forming an opening 220 mm wide and 640 mm high. Externally the surround has an eroded narrow flat chamfer. The cill remains only on the exterior; internally the base of the window is truncated by the segmental arch of a blocked, inserted doorway (F7). The small window is integral to the surrounding wall and is sited with its head just beneath the original top of phase-1 wall F1. When doorway F7 and windows F10 and F18 were inserted this window was evidently blocked up and is therefore not shown in any of the late 18th and 19th-century illustrations, though it was evidently visible as a recognizable feature in 1849 when it is mentioned in a description of the church made by Ross for his 6th edition of the 'Hastings and St. Leonards Guide'.</p>

*Round-headed window (F6).*

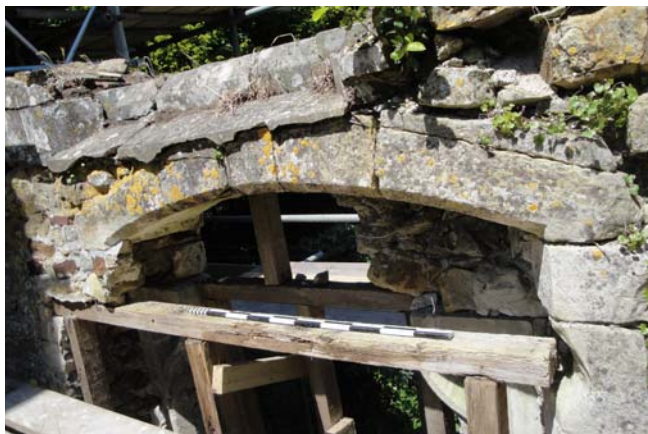
The fragmentary remains of a two-light window, formerly with internally splayed jambs. The window is now replaced and cut by nineteenth-century window F4 which is set at a slightly lower level and slightly to the west. As a result, it is now only visible within the south (internal face) of the wall. Here the segmental rear-arch remains intact, as does the eastern splayed jamb, complete with dressed stone quoins. The bottom of the lowest quoin indicates the original cill level, which was positioned noticeably higher in the wall than the level of the cill to inserted window F4. The intact chamfered rear-arch indicates that the opening was 1.60 metres wide internally, reducing to 1.26 metres at the (removed) external frame. The rear-arch cuts the

*Rear arch of two-light window (F10).*

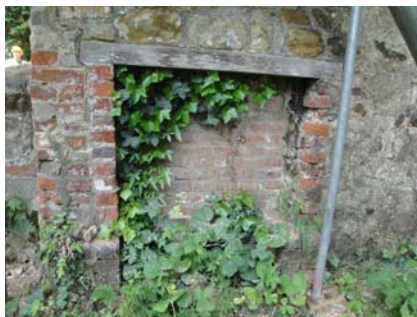
Fireplace cut back into the wall of the tower. This 890 mm wide fireplace was inserted to serve the vestry. The front face of the fireplace has mostly been cut back, but its one-brick wide jambs still retain their full depth at the base where they project from the old wall face by 125 mm. A modern timber lintel supports modern patching F12 extending up the wall face.

*Fireplace (F11).*

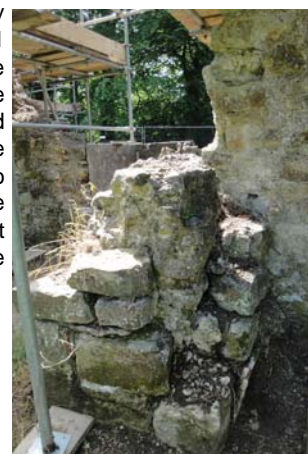
Remains of a buttress, 900 mm wide with a projection of 900 mm, built against the north face of the nave wall at its extreme eastern end. It is straight jointed to wall F1, except at two points where the wall face has been cut into in order to allow the buttress to be keyed in. There are the distinct remains of a gritty mortar render to wall face F1 behind the point where the buttress meets the wall. The quoins of the buttress are faced in rough ashlar sandstone. The buttress is usually attributed to the 13th century, though there are no visible features to date it any more closely than the medieval period.

*Right:- Buttress (F13).*

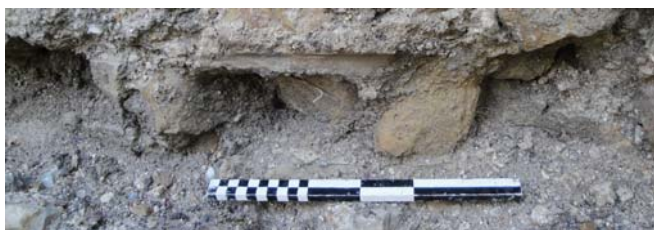
*Window G2. Rear (northern) edge of phase-5 window cill visible as an impression in the mortar.*

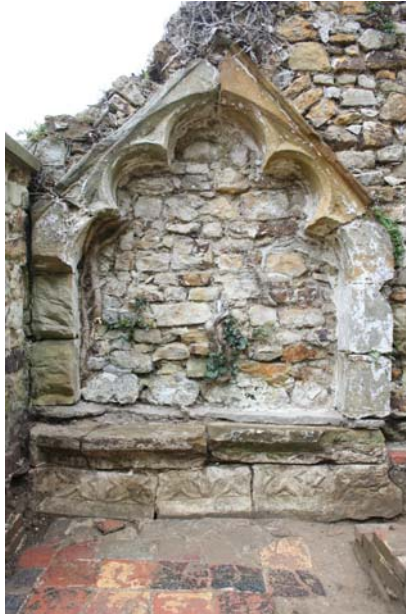
G5	Canopied Tomb	4	L13/E14C	A canopied tomb seemingly (at least in the area of the canopy) integral with the fabric of the wall in which it is set. Its rear wall is recessed partially into the wall of the chancel, whilst jambs, canopy and tomb chest project slightly. Its cinquefoiled hood is set beneath a scroll-moulded upper order and was described by Glynne [Bullock p. 52] in about 1826 as being 'surmounted by a cross for a finial', but this no longer survives, though its mounting is still just discernible. The wall immediately above the upper part of the canopy incorporates a 'relieving arch' formed of neat rubble masonry. The western jamb of the canopy has been cut back slightly on its west side. The canopy itself has a chamfered cinquefoil head set beneath a chamfered two-centred arch. The cusps are fully engaged with the arch. Clearance has revealed that the base of the tomb chest is concealed by a considerable rise in ground level within the chancel. Its south face is decorated with a frieze of quatrefoils set back within a deeply chamfered surround, the extreme eastern end of which has been damaged. Over the upper blocks of the frieze and extending under the side jambs supporting the canopy is a large, thin slab of shelly limestone/marble of which only the rear part and ends now survive <i>in situ</i> . It is therefore impossible to tell whether this represents the matrix for a former brass, though the likelihood is that it does. Part of an encaustic tile floor exists in front of the

*Canopied  
Tomb (G5).*

chest. Although far less elaborate, the arch of the canopy has similarities to those over the sedilia at Winchelsea church which dates from the years around 1300.

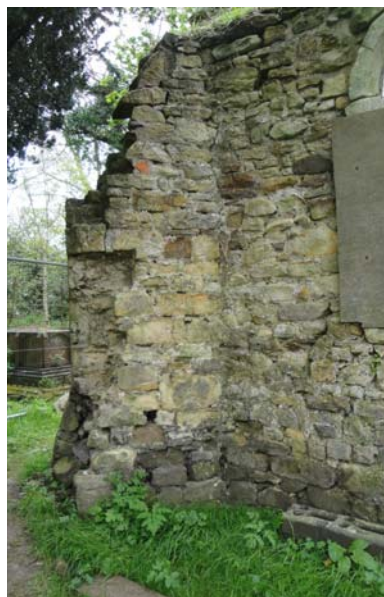
An 880mm wide diagonal buttress added to give strength to the north-eastern corner of the chancel. It is straight-jointed to both the north and east walls of the chancel, with very occasional block bonding fitted into small sockets cut into the face of the existing walls. In both cases the buttress traps external render on the walls. At the base, rising from the present ground level (which is likely to be higher than originally) is a 770 mm high sloping offset above which the buttress rises vertically and projects 1.05 metres from the wall face. The north-western quoin has been damaged and has largely fallen, whilst the north-eastern quoin is at one point repaired in brick. The offset at the apex of the buttress is also damaged, but the upper part is

*Buttress (G6).*

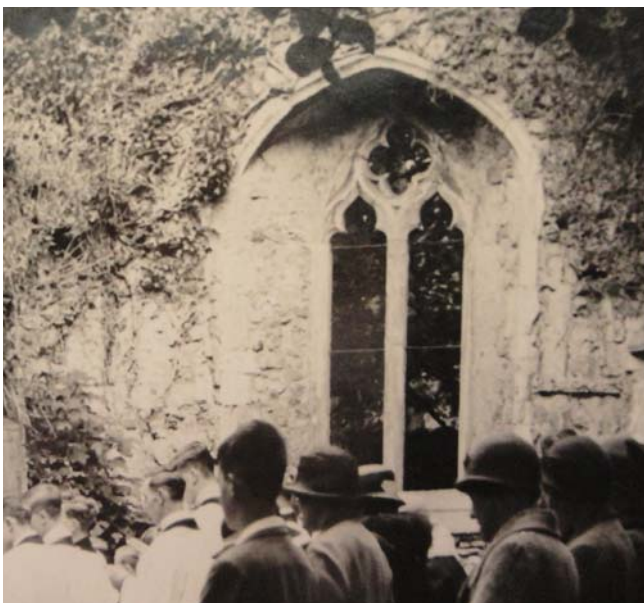
*Chancel window (H2).  
[Photograph from HAARG archives].*

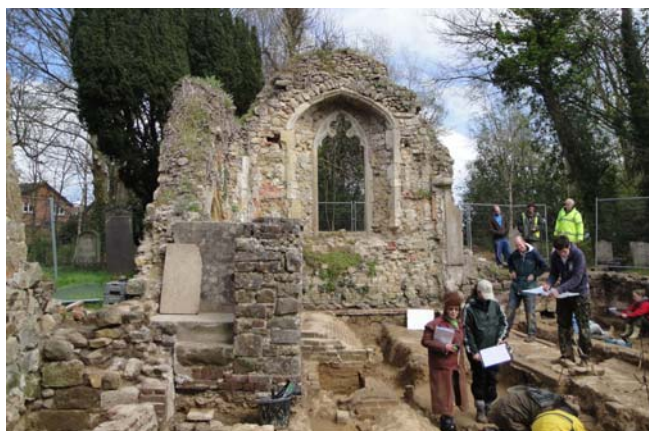
*General view of east wall of Chancel  
 showing east window (H2).*

The generally accepted view offered by most commentators is that this window represents a 14th-century insertion into a 13th-century wall. However, as Morgan has observed, all indications are that the wall is undisturbed and the window is integral to the surrounding stonework. Furthermore, the mouldings on the hood and the details of the relieving arch are all but identical to those used for the canopied tomb (G5) in the north wall of the chancel and, as already noted, all three surviving chancel windows incorporate reused stones within their internal quoins. Undoubtedly, the east window is of Decorated type, but such windows are found in a late 13th-century context, as for instance at Tonbridge Castle Gatehouse, Kent (third quarter of the 13th century), Stokesay Castle, Shropshire (1281x1291) and — in more elaborate form — within St. Thomas's Church, Winchelsea (c.1300). In addition, it is worth noting that the two-light windows at Tonbridge Castle are found in conjunction with standard lancet windows and lancet windows of standard design were used as late as 1385 at Bodiam Castle. The twirl stops to the hood at Ore are very distinctive and almost identical to a number of such stops which both survive and have been recovered from excavations within the town of Winchelsea, all dating from a known c.1300 context. All this indicates that there is no reason why the window cannot be contemporary with the reconstruction of the chancel.
